Technology of welding and repair works of hydropower plants units

Abstract. In the course of long-term operation of hydroelectric units, they are subject to wear and tear, which negatively affects the power generating capacity of the hydroelectric power station. The existing repair technology provides the restoration of the geometric dimensions of the impeller chamber of the hydraulic unit using an austenitic cladding layer. However, this technology is characterized by the occurrence of cracks and delamination of the deposited layer during post-repair operation, which is negatively reflected in the production cycle of electricity. A new technology and welding consumables have been proposed for repair and restoration works of hydroelectric units at hydroelectric power plants, providing an increase in the quality level, high characteristics of hydroabrasive and cavitation resistance, and increasing of working period of hydroelectric power plants. Inspection of the body of the hydraulic unit was carried out, defects were identified and classified, the reasons for their occurrence were analyzed. The research results make possible to optimize the alloying system of the deposited metal,

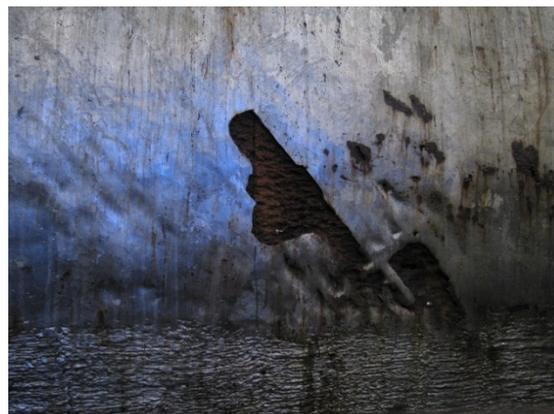
3. At the time of inspection, about 50% of the cladding was exposed to significant pitting and pitting corrosion;
4. A significant number of local defects and breaks of the cladding layer noted, under which pitting corrosion of the base metal reaches more than half of the wall thickness. Cases of through corrosion observed in the places of such breaks;

8. In the upper part of the chamber, at the transition boundary of the cladding layer, there is a band of intense pitting corrosion of the base metal to a depth of 15...20 mm, with a width of up to 200 mm. In the zone of repair welding with austenitic filler materials, significant corrosion is noted along the boundaries of the surfacing with a depth of up to 20 mm, which indicates an increase in the rate of this process along the boundaries of dissimilar surfacing;

10. The performed repair protective austenitic surfacing in the lower part of the chamber at the border of the transition of the old cladding layer to the base metal characterized by significant pitting corrosion. This type of damage extends practically around the entire perimeter of the chamber. In most cases, corrosive wear is practically through, which requires the need for mandatory repair and restoration work in this area;

Fig. 2. Corrosion of the base metal and cladding layer

The appearance of the corroded areas of the chamber, where it is necessary to carry out repair and restoration work, it is shown at Fig. 2–3.

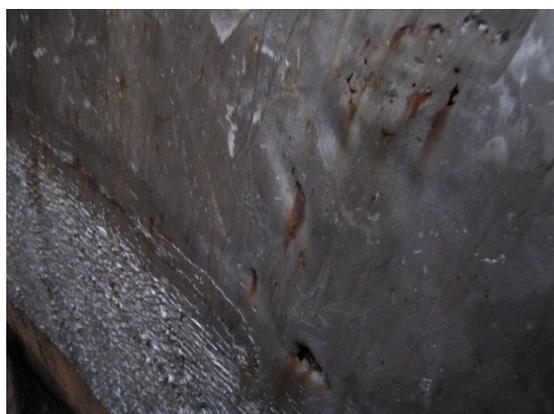
Fig. 3. Corrosion of deposited layer

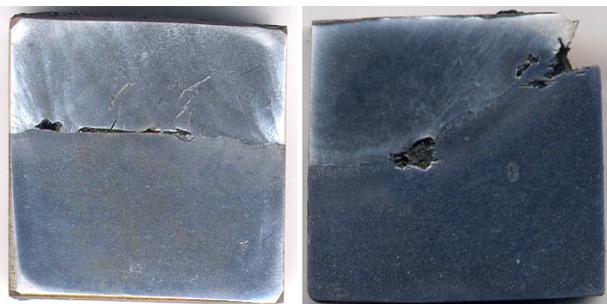
Studies of the manufactured samples showed, that the destruction of the layer deposited with coated TsL-11

electrodes occurs through the formation of cracks, delamination and corrosion in it (Fig. 4), as well as cracks in the deposited metal along the grain boundaries (Fig. 5).

Fig. 4. Appearance of sample defects

Thus, we can conclude, that the destruction of the metal deposited with TsL-11 electrodes of the E-08Cr20Ni9Mn2Nb type on the working surface of the lining of the hydraulic unit impeller chamber made of Steel 3 is due to the formation of a martensite phase in the transition zone, initiating corrosion, cracking and peeling of the high-alloy layer.

In order to improve the quality and reduce the quantity of defects during repair, using the existing welding and repair technology for restoring the operability of the impeller chambers of hydraulic units, a new type of alloying of the deposited metal was selected, and new coated electrodes of the ANV-70BG type E-10Cr28Ni14Mn2 type were developed and manufactured.

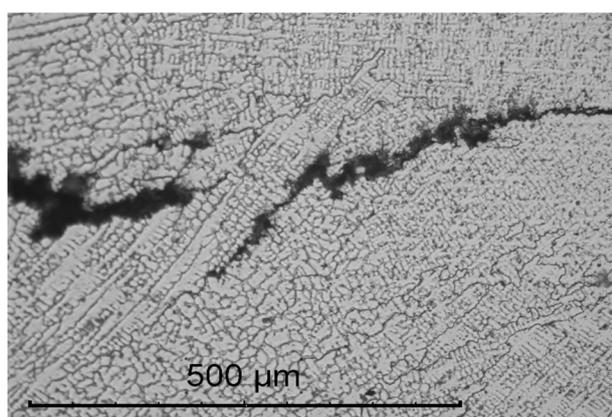
Fig. 5. Appearance of a crack in a weld metal along grain boundaries, x200

2. Due to the mixing of the pearlite (base) metal with the austenitic (TsL-11), a chemical heterogeneity is formed with a reduced content of chromium and nickel, which leads to the formation of brittle martensite interlayers, which initiates the formation of cracking;

This research studies have determined, that in order to minimize the risk of martensite formation in the transition zone and subsequent destruction of the deposited layer, it is necessary to limit the value of the welding current (no more than 90 A for electrodes type

E-10Cr28Ni14Mn2 \varnothing 3 mm), which ensures the transition zone microhardness at the 1595...2580 MPa level.
