The research of the railway rail for analysis of surface initiated rolling contact fatigue cracks

Yurii Borodii¹ • Pavlo Protsenko¹ • Andrii Petryshyn¹ • Eckart Uhlmann² • Janis Thalau² • Pavlo Lypovka² • Volodymyr Horbyk³ • Viktor Hlukhovskiy³

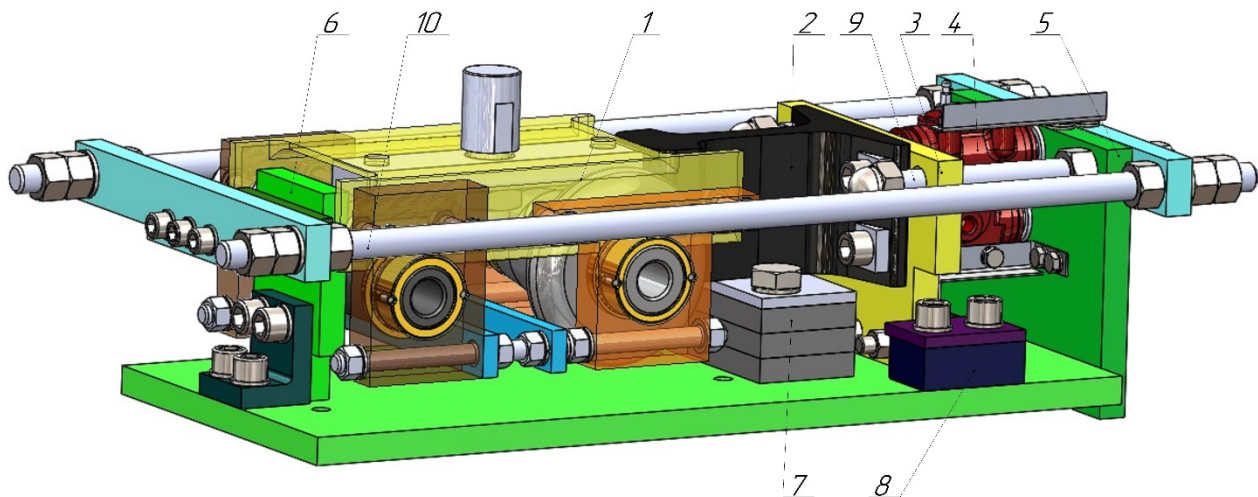
Fig. 1. Experimental setup 3D model: 1 – running head; 2 – rail; 3 – movable plate; 4 – hydraulic system; 5 – fixed plate; 6 – guide roll; 7 – set of base plates for the rail; 8 – guide for the movable plate 3; 9 – guide axis for the movable plate 3; 10 – stud-bolt for greater rigidity setup

Core material and results. For research of rails for contact damage, the experimental setup has been designed and manufactured. Experimental setup 3D model is shown in Fig. 1. The experimental setup contains the following main parts: the running head, which is shown in fig. 2; hydraulic system, the scheme of which is shown in Fig. 3; table with different guides and fixing plates (Fig. 1). The setup is mounted on a mechanical single-cylinder press of the K 2322 model with a nominal force of 16 tons at a nominal stroke frequency of 120 per minute. The running head is fixed to the slide of the press KD 2322. Fig. 4 presents a general view of the experimental setup that mounted on press of the K 2322 model. Fig. 5 shows a “rail-wheel” friction unit. Fig. 6 presents a general view of the hydraulic system that provides clamping force of the rail to the wheel.

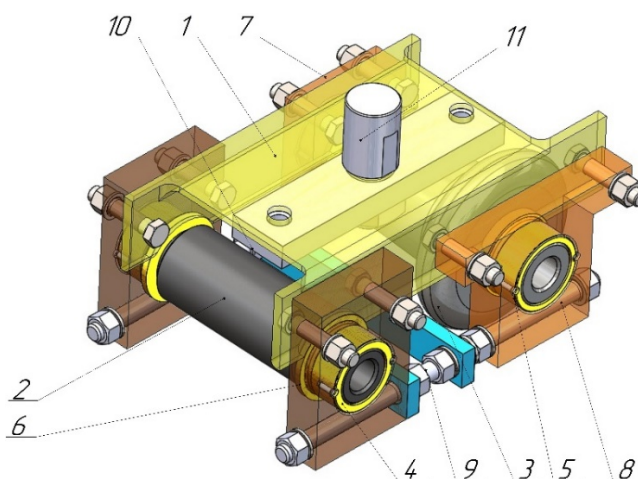
Fig. 2. Running head: 1 – channel; 2 – roll; 3 – shaft-wheel; 4, 5 – bushings; 6, 7, 8 – housings; 9 – stud; 10 – holder, 11 – shank

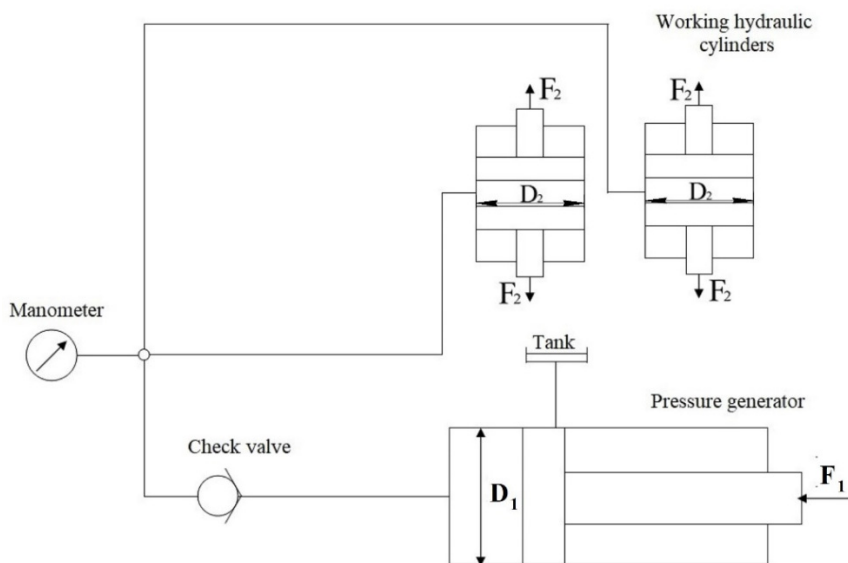
Fig. 3. The hydraulic system of the experimental setup

Knowing the required force that must be generated by the piston, you can calculate the required pressure in the hydraulic system:

$$p = F_w^{\text{setup}} / S_p \cdot n, \quad (3)$$

where S_p is piston area; n is the number of hydraulic cylinders (the setup contains two hydraulic cylinders, $n = 2$).

The pistons of the hydraulic cylinders have a diameter $D_2 = 35 \text{ mm}$. Then to create needed force F_w^{setup} the pressure in the hydraulic system must be: $p = 1.95 \approx 2 \text{ MPa}$.

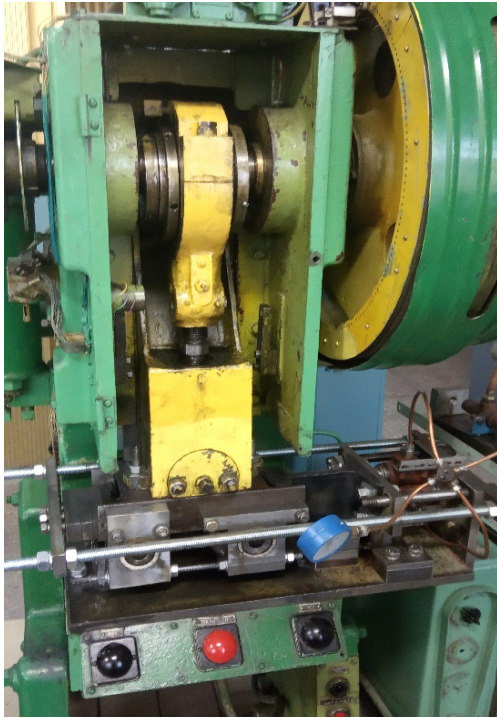
Fig. 4. General view of the experimental setup mounted on mechanical single-cylinder press of the K 2322 model with a nominal force of 16 tons

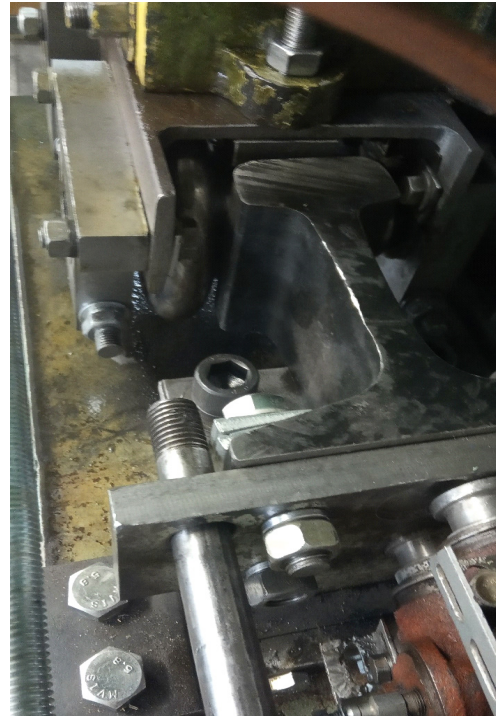
Fig. 5. General view of the friction unit "rail-wheel"

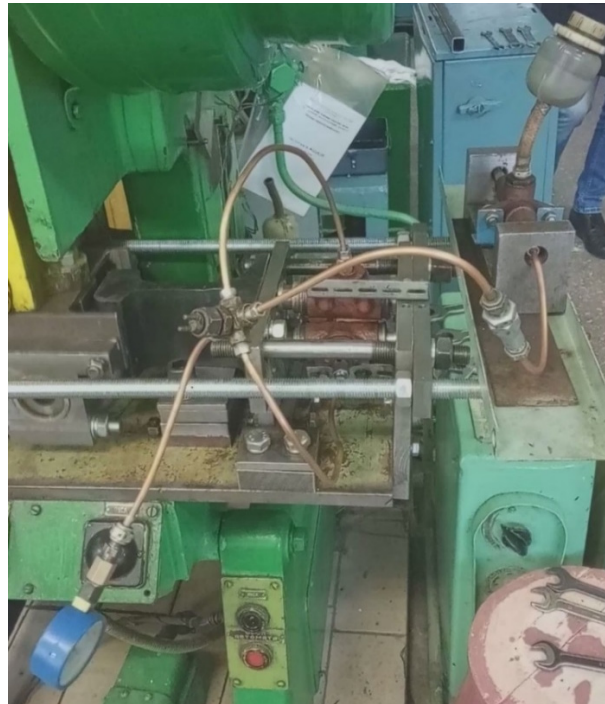
Fig. 6. General view of hydraulic system of the setup

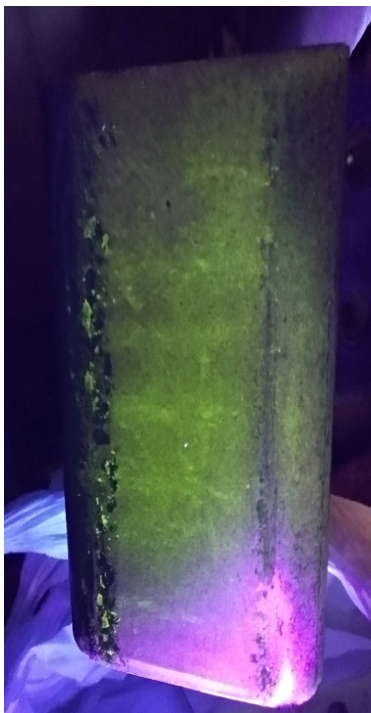
Fig. 7. Photo of the rail before testing

Before testing the rail in the setup (fig. 7), its surface was examined for cracks using the fluorescent magnetic particle inspection. In fig. 7 shows the image of the original rail during testing for the presence of cracks. As can be seen from fig. 7, there are no cracks on the working surface of the rail. The image can be distinguished areas of the surface that deviate from the norm, but are not surface defects that affect the performance of the rail and do not reflect in UV light.

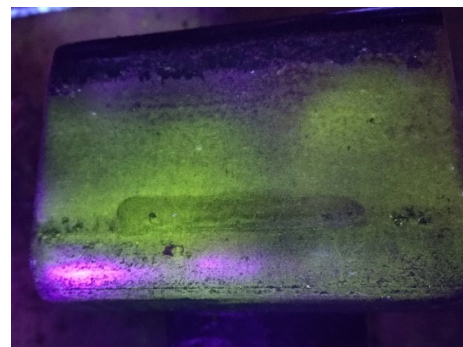
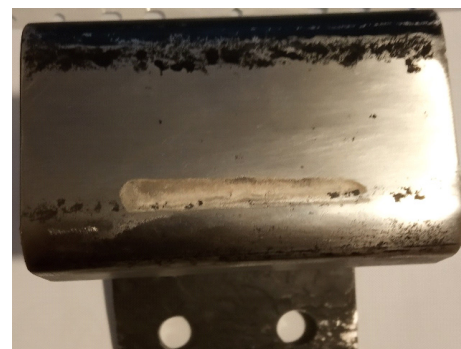
Fig. 8. Photos of the rail wear zone after 31920 load cycles: *a* – image of the rail wear zone in UV light during flaw detection; *b* – photograph of the rail wear zone

In Fig. 8, *a* shows an image of the rail wear zone in UV light after 31920 load cycles. In Fig. 8, *b* presents a photograph of the wear zone of the rail. There are no visible cracks on the surface of the rail.

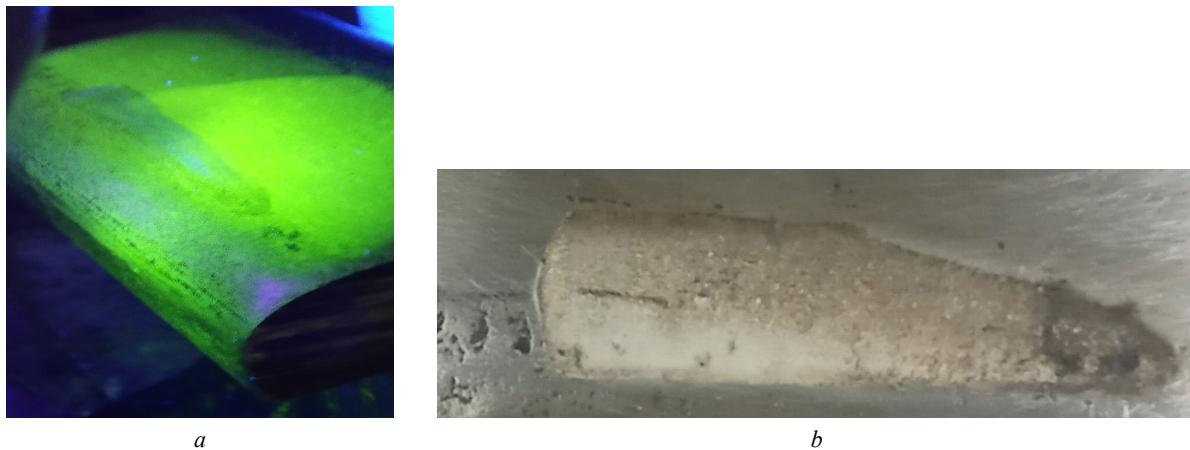
Fig. 9. Photos of the rail wear zone after 95760 load cycles: *a* – image of the rail in UV light during flaw detection, *b* – photograph of the rail wear zone

A similar picture without cracks, as in Fig. 8 is shown in fig. 9 after 95760 load cycles.

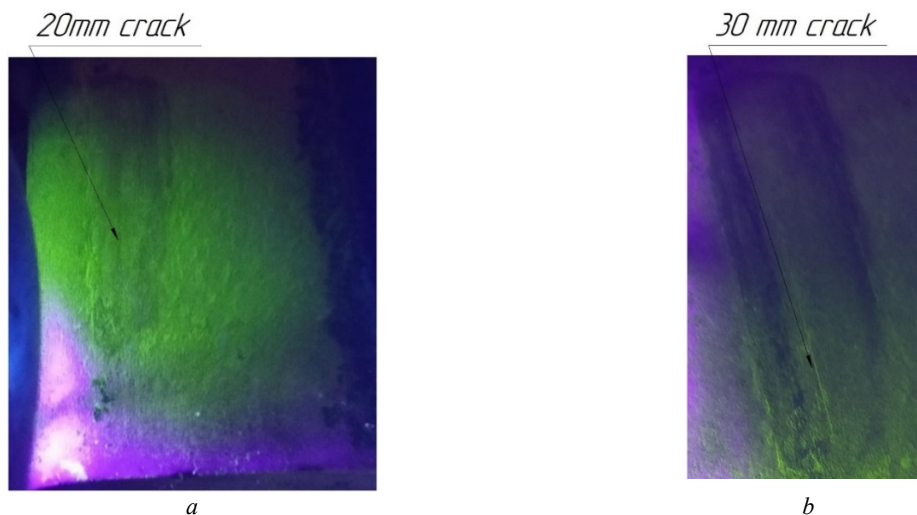
Fig. 10. Photos of rail wear zones with cracks: *a* – after 218120 load cycles with 20 mm crack, *b* – after 255360 load cycles with 30 mm crack

The crack initiation began after approximately 200–210 thousand load cycles. The first crack was fixed at 218120 load cycles (fig.10, *a*). Its length was 20 mm. In fig. 10, *b* shows the photograph of the wear surface of the rail after 255360 load cycles. Several cracks are clearly distinguished and tend to develop along the contact zone of the rail and shaft-wheel with indicated numbers of the load cycles (255360). This is broadly in line with the results presented in [10], which shows the occurrence of similar damage after 190-290 thousand load cycles, depending on the properties of rail steel (hardness, surface roughness, etc.).

As can be seen from table 1, the average crack growth rate is 0.0005 mm / load cycle after its occurrence. In addition, the number of cracks doubles approximately every 30 thousand load cycles since the first crack

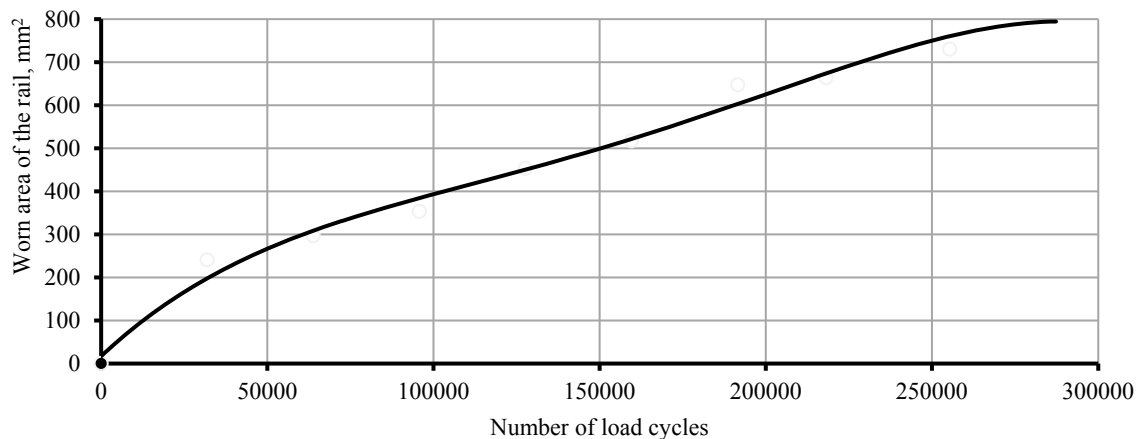
Fig. 11. The dependence of the number of load cycles on the worn area of the rail

During the investigation of contact damage rail on the setup, in addition to detecting fatigue cracks and other surface defects, the shape and size of the wear zone were also determined. As can be seen from fig. 8, *b* and fig. 9, *b*, the shape of the worn zone of the rail is close to a rectangular trapezoid. This can be explained by the peculiarities of the experimental setup, when the force of pressing the rail to the wheel increased while the slider moves down. During the upward stroke, the pressing force decreased and its value was in the range of 3–5 kN. In the process of moving the slider, the pressure also varied in the hydraulic system from 1.5 to 3 MPa. The maximum pressure was in the lowest

position of the slider. The relationship between the number of the load cycle with the worn area of the rail is presented as the graphical dependence in fig. 11.

4. The worn area appears and increases on the surface of the rail during the wheel and rail come in contact. The worn area on the rail was already formed after the first test stage (31920 load cycles for 2 hours testing) with an area of about 241 mm². The shape of the worn area of the rail is close to a rectangular trapezoid. This can be explained by the peculiarities of the experimental setup, when the force of pressing the rail to the wheel increased while the slider moves down. During the upward stroke, the pressing force decreased and its value was in the range of 3–5 kN. As the number of load cycles increased from 31920 to 287280, the worn area of the rail increased from 241 to 800 mm².
